## MRI Safety Hazard from Undetected Metal Thread in Clothing

Mark C Oswood<sup>1,2</sup>

<sup>1</sup>Consulting Radiologists, Ltd, Minneapolis, MN, United States, <sup>2</sup>Radiology, Abbott-Northwestern Hospital, Minneapolis, MN, United States

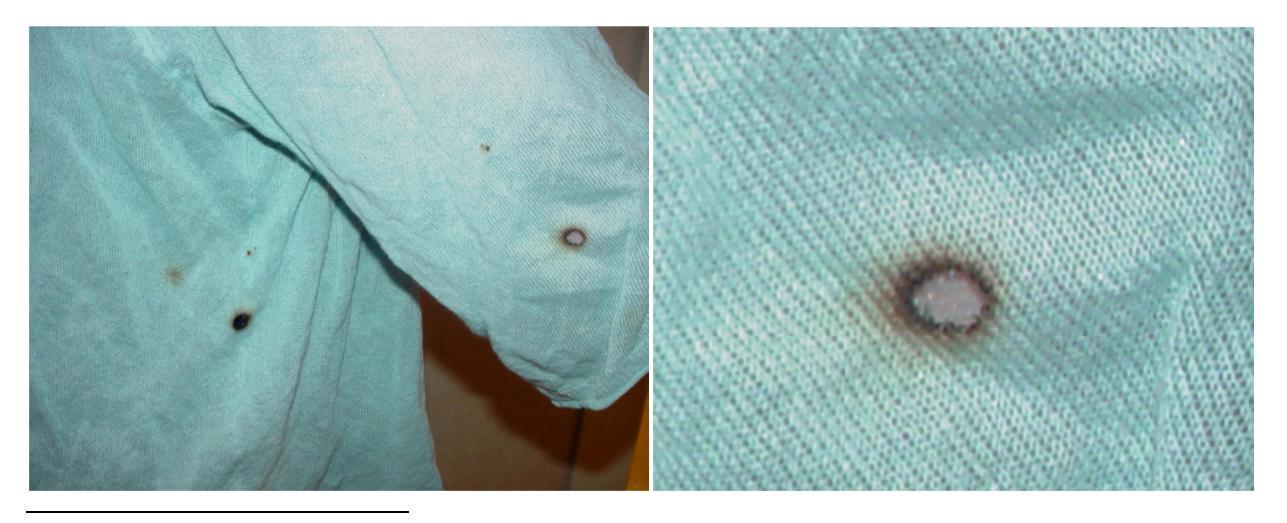
**Case report**: An adult woman presented to the hospital for a routine outpatient lumbar magnetic resonance (MR) examination. Pre-examination safety screening was performed and the patient was cleared for MR imaging. The patient was placed in a 1.5 T whole body scanner. After performing the first sequence, a fast spin echo T2-weighted sagittal image of the lumbar spine, the patient complained that her skin was hot. The technologist removed the patient from the scanner and found that the patient's shirt was burned (see photograph). Examination of the label on the shirt revealed the presence of metal thread. The metal was not apparent to the patient or the MR technologist prior to the examination. As seen on the enlarged photograph, the metal thread is not readily apparent on visual inspection.

Lurex is a thread with aluminum coating used in clothing. The aluminum coating is a radiofrequency conductor. Clothing woven with metal (lurex) thread therefore presents a hazard to patient if worn during MR examination.<sup>4</sup> As demonstrated in this case, the metal thread may not be readily apparent on examination of the fabric. A case report from 1987 described susceptibility artifact due to steel thread woven into a patient's pants.<sup>5</sup> However, a literature search revealed no previous case reports of burns due to metal thread woven into garments.

**Conclusion:** Any clothing with metal (lurex) thread should be removed prior to MR imaging. Because of the apparent difficulty of recognizing the presence of metal thread in clothing, MR facilities should consider requiring patients to change into a metal free cloth gown prior to any MR examination.
